ANNUAL REPORT FOR 2004

UT to Briery Run Mitigation Site (Crescent Road Site)
Lenoir County
WBS Element 34501.4.1
TIP No. 2719WM

Prepared By:
Office of Natural Environment & Roadside Environmental Unit
North Carolina Department of Transportation
March 2005

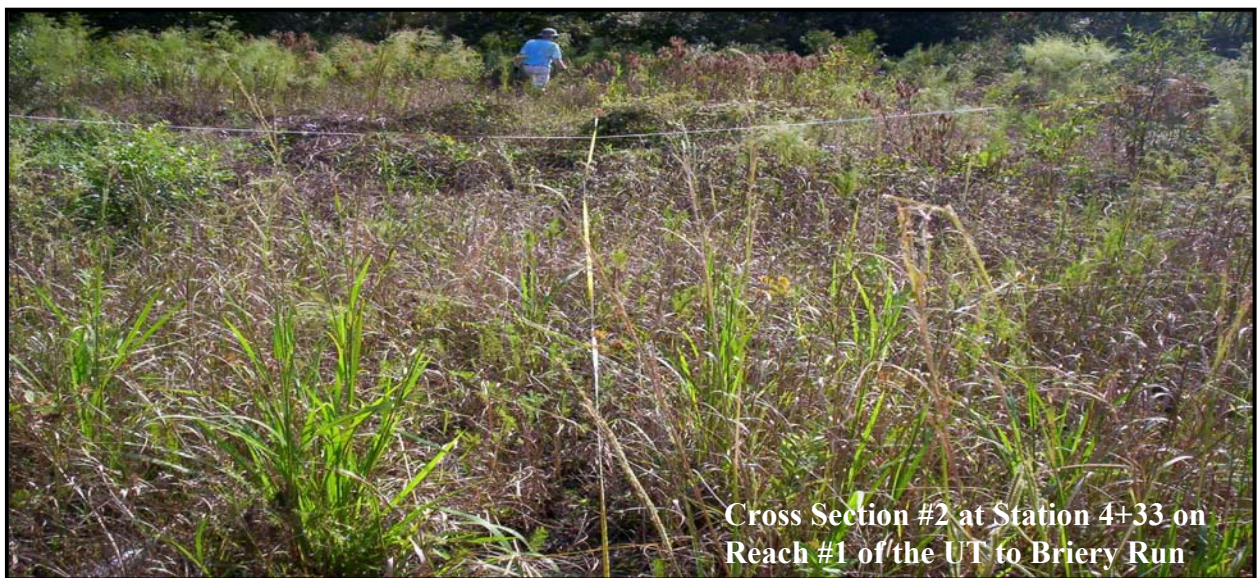
Cross-Section #2 (Glide) Abbreviated Morphological Summary*

2004	2005	2006	2007	2008
Bankfull Cross Sectional Area (ft ²)	8.6				
Maximum Bankfull Depth (ft)	2.3				
Bankfull Mean Depth (ft)	1				
Bankfull Width (ft)	8.6

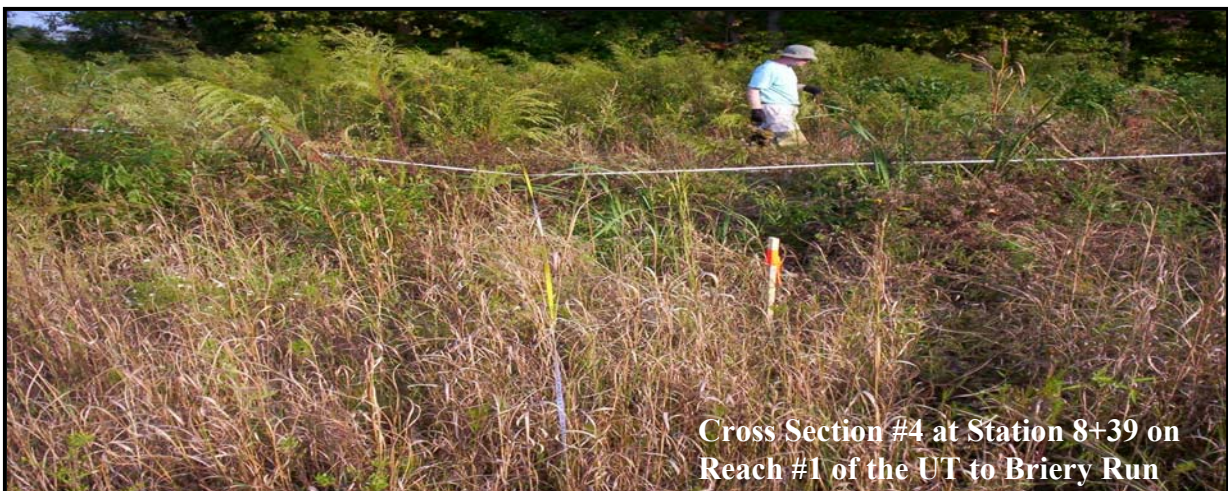
Cross-Section #4 (Riffle) Abbreviated Morphological Summary

2004	2005	2006	2007	2008
Bankfull Cross Sectional Area (ft ²)	7.2				
Maximum Bankfull Depth (ft)	2				
Bankfull Mean Depth (ft)	0.9				
Bankfull Width (ft)	8				
Width of the Floodprone Area (ft)	100				
Width/Depth Ratio	8.9				
Entrenchment Ratio	12.5

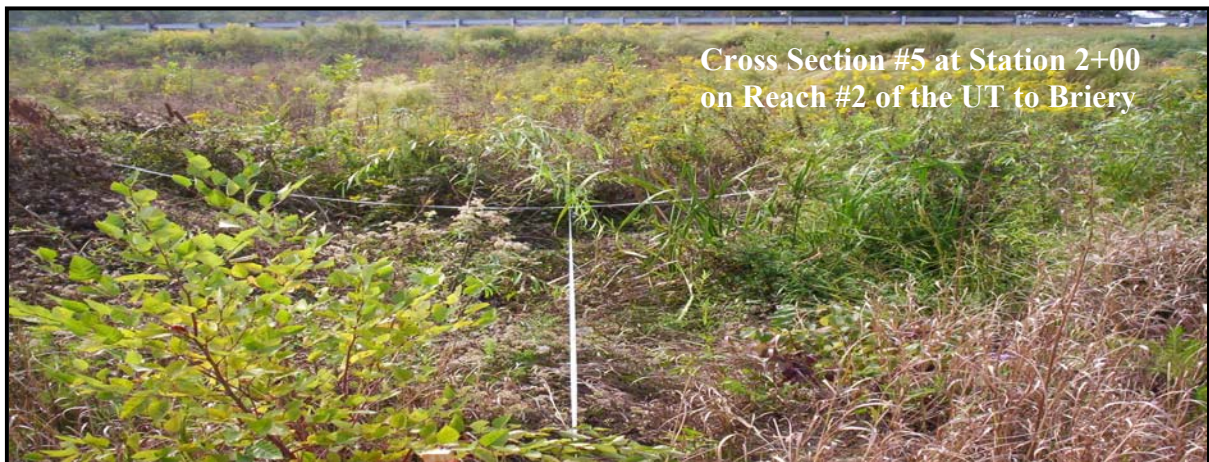
Cross-Section #5 (Riffle) Abbreviated Morphological Summary

2004	2005	2006	2007	2008
Bankfull Cross Sectional Area (ft ²)	11.3				
Maximum Bankfull Depth (ft)	1.4				
Bankfull Mean Depth (ft)	0.7				
Bankfull Width (ft)	16.2				
Width of the Floodprone Area (ft)	100				
Width/Depth Ratio	23.1				
Entrenchment Ratio	6.2

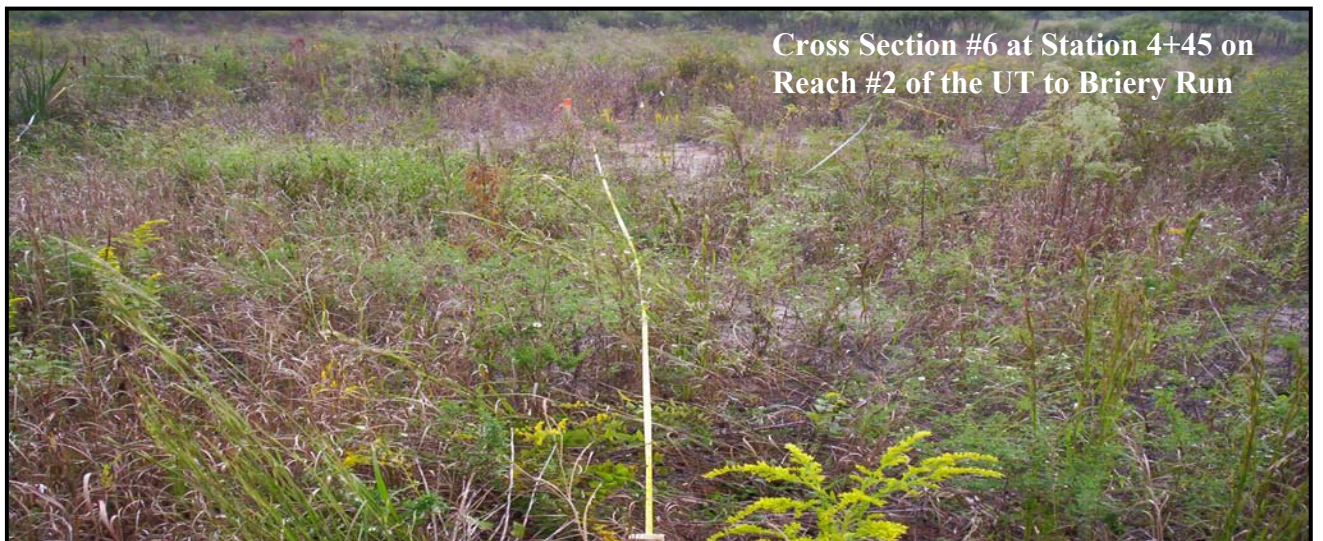
Cross-Section #6 (Rifle) Abbreviated Morphological Summary

2004	2005	2006	2007	2008
Bankfull Cross Sectional Area (ft ²)	16.4				
Maximum Bankfull Depth (ft)	2				
Width of the Floodprone Area (ft)	100				
Bankfull Mean Depth (ft)	0.9				
Width/Depth Ratio	20.2				
Entrenchment Ratio	5.5				
Bankfull Width (ft)	18.2

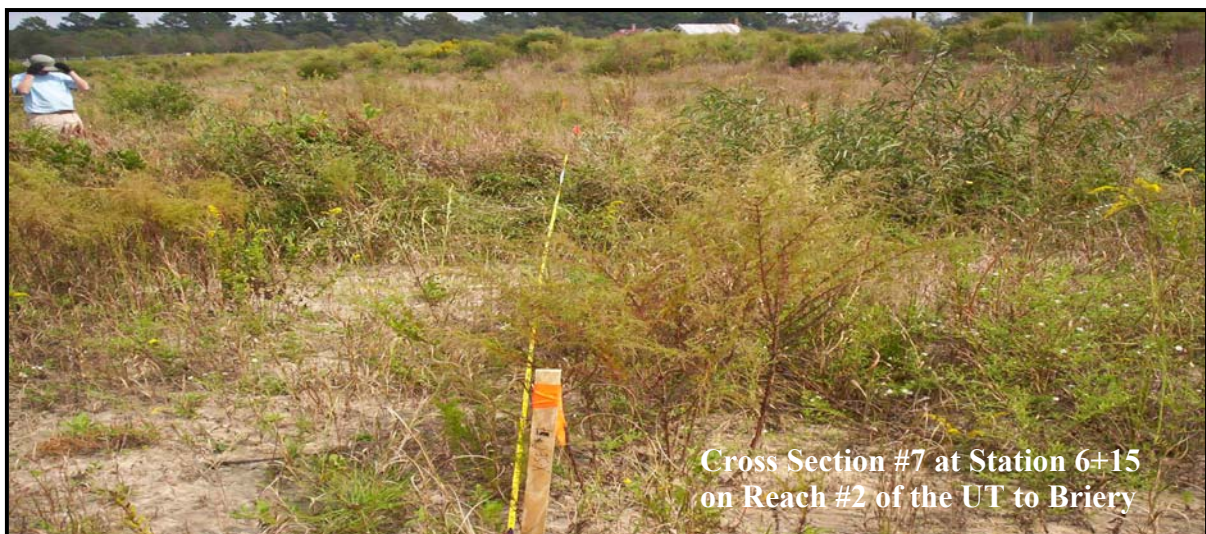
Cross-Section #7 (Glide) Abbreviated Morphological Summary*

2004	2005	2006	2007	2008
Bankfull Cross Sectional Area (ft ²)	9.7				
Maximum Bankfull Depth (ft)	1.7				
Bankfull Mean Depth (ft)	0.6				
Bankfull Width (ft)	16.2

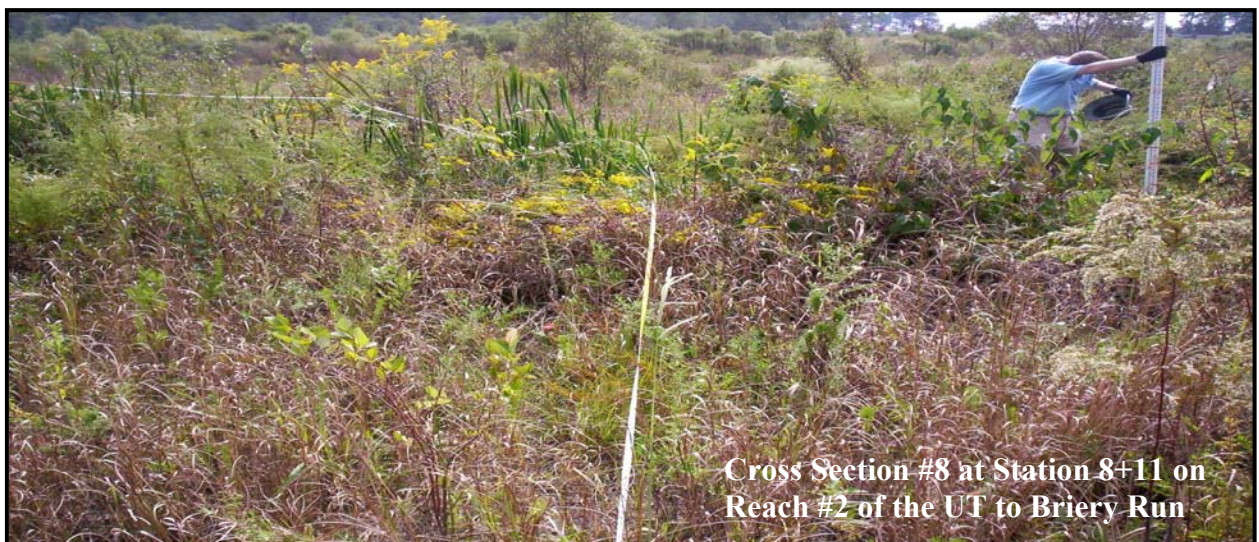
Cross-Section #8 (Glide) Abbreviated Morphological Summary*

2004	2005	2006	2007	2008
Bankfull Cross Sectional Area (ft ²)	8.8				
Maximum Bankfull Depth (ft)	1.6				
Bankfull Mean Depth (ft)	1.0				
Bankfull Width (ft)	8.8

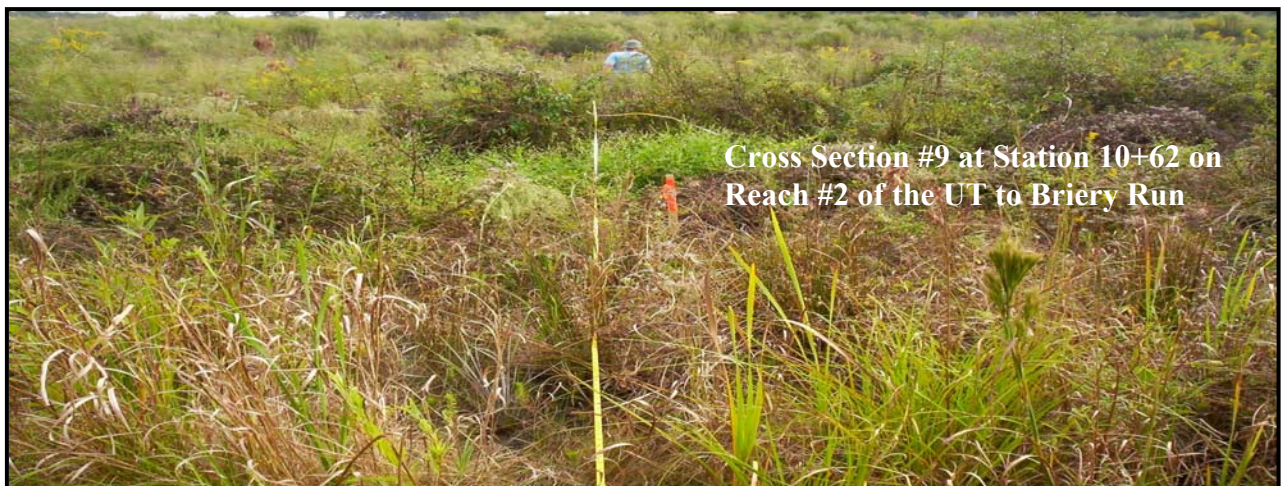
Cross-Section #9 (Riffle) Abbreviated Morphological Summary

2004	2005	2006	2007	2008
Bankfull Cross Sectional Area (ft ²)	9.2				
Maximum Bankfull Depth (ft)	1.6				
Bankfull Mean Depth (ft)	0.9				
Bankfull Width (ft)	10.2				
Width of the Floodprone Area (ft)	100				
Width/Depth Ratio	11.3				
Entrenchment Ratio	9.8
